METALS HANDBOOK

VOL. 9
FRACTOGRAPHY AND ATLAS OF FRACTOGRAPHY

8th EDITION

Fractography and Atlas of Fractographs

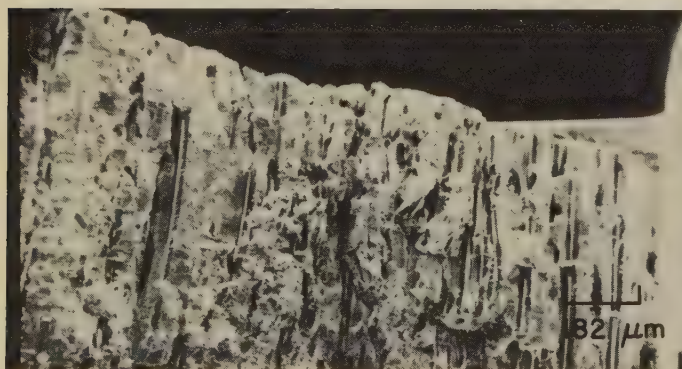
55×

4114 Surface of a transverse compressive fracture in a sheet of BORSIC-aluminum composite. The BORSIC fibers are 4.2 mils in diameter; the matrix is foils of aluminum alloy 6061 plasma-arc sprayed with powder of the same alloy. Here, as in fractograph 4111, the fibers split longitudinally. Also visible is the result of shear deformation of the matrix.

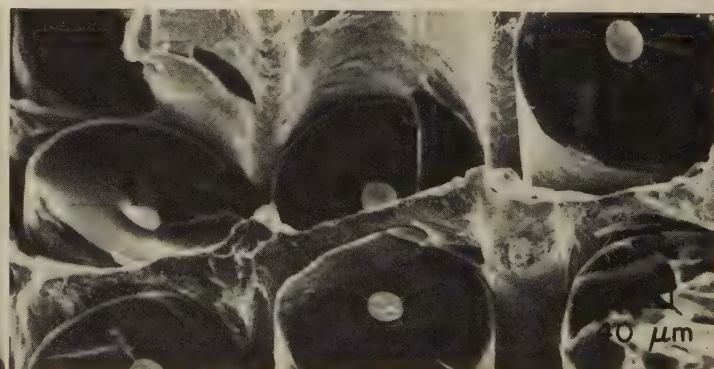
250×

4115 Surface of a longitudinal tensile fracture in a sheet of BORSIC-titanium composite, which may be compared with the transverse tensile fracture in the sheet of BORSIC-aluminum composite shown in 4112. Note the smooth cleavage facets on the BORSIC fibers here, and the manner in which the titanium alloy matrix was deformed by being pulled from the fibers.

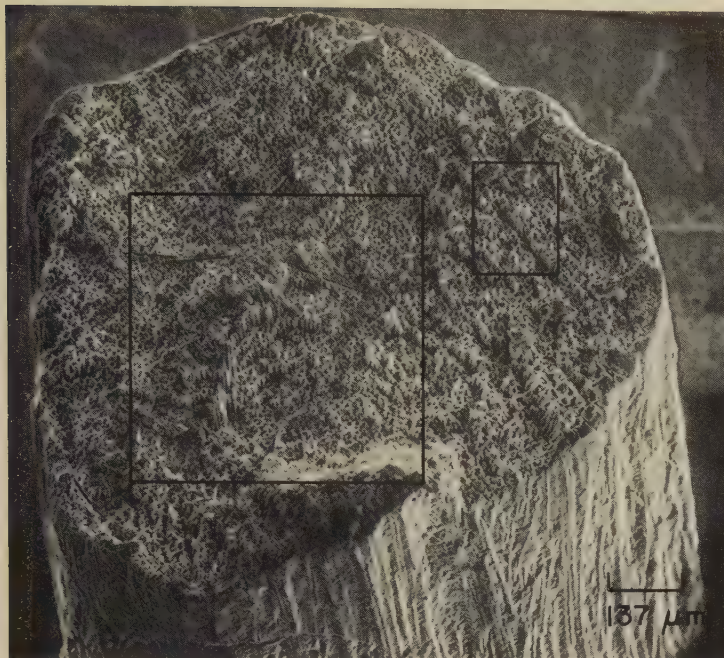
73×

4116 Surface of a fracture in a longitudinal tensile-test specimen of a carbon (graphite) - magnesium composite having a tensile strength of 640 MPa (93 ksi). The approximate makeup of the composite was 40% graphite fibers (Modmor type I) and 60% magnesium matrix (99.5% pure), by volume. See also fractographs 4117 (at right) and 4118 (below, at left) for higher-magnification views of the areas outlined by the large and small rectangles, respectively. See also fractograph 4120 (below, at right).

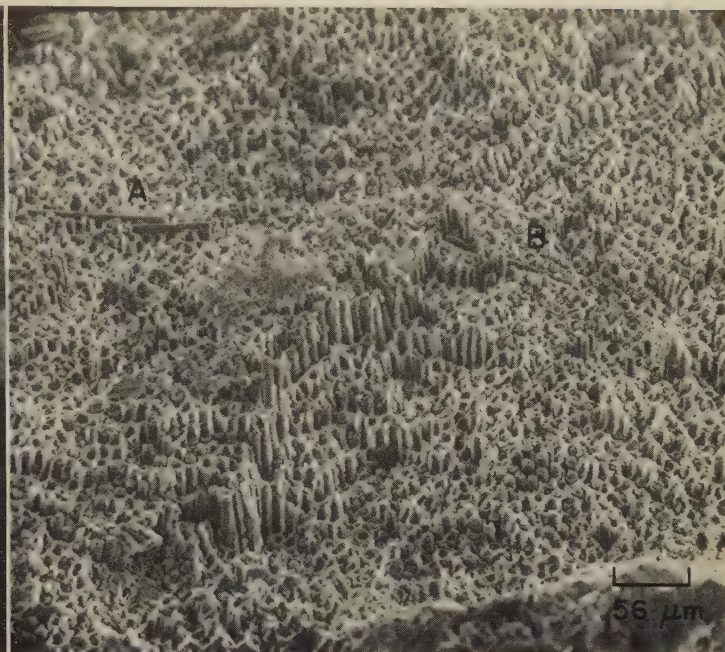
180×

4117 Higher-magnification view of the area in the larger rectangle in 4116 (left). At letter A are two transversely oriented features that appear to be graphite fibers that either are lying loose on the surface or were inadvertently misaligned during manufacture. The feature at B is probably a ridge. Much of the surface exhibits broken fibers, the ends of which are roughly in the same plane as the fracture in the surrounding matrix, but at center are exposed fibers with the appearance of "palisades".

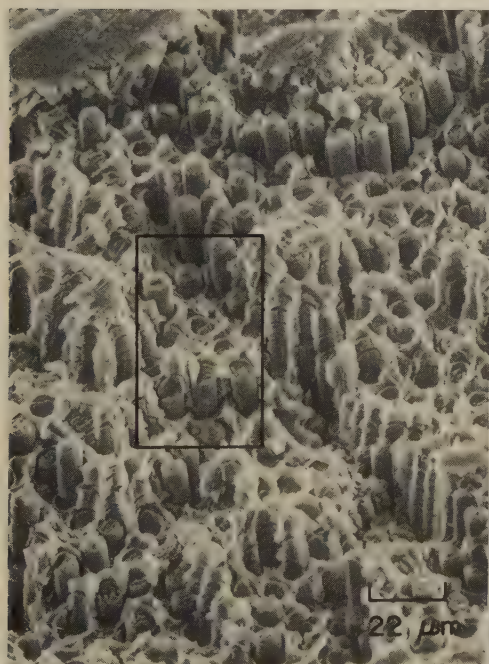
450×

4118 Higher-magnification view of the area in the smaller rectangle in 4116, showing "palisades", some of which are the reverse of those in 4117 in that the fibers have broken at the bottom of the "palisades", exposing the sides of the holes in the matrix. See 4119 (right) for an enlarged view of the area in the rectangle.

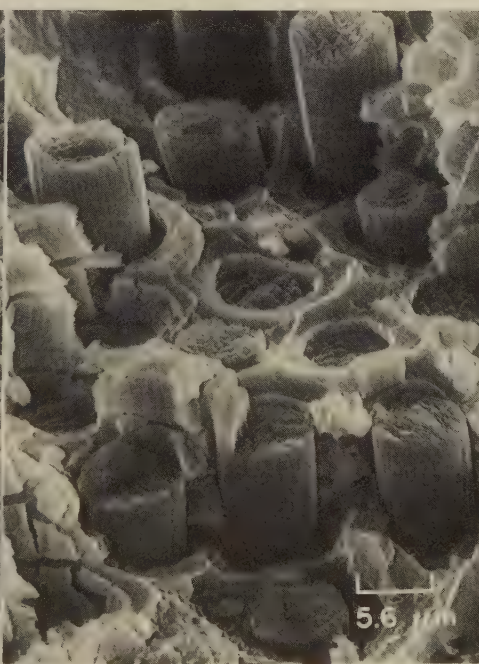
1800×

4119 An enlargement of the area in the rectangle in fractograph 4118 (left), showing that the magnesium matrix fractured in a brittle manner; note the many transverse fissures in the sides of the holes. Note also that the surfaces of the holes in the matrix reflect faithfully the fluted contours of the graphite fibers.

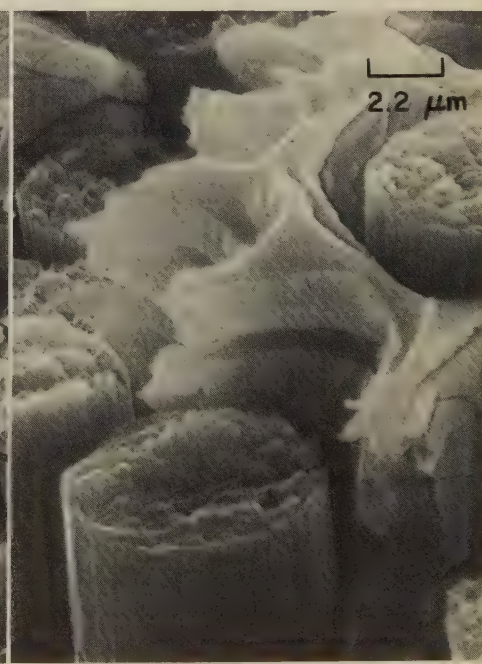
4500×

4120 A view at higher magnification of an area of the fracture surface shown in fractograph 4116 (above). The rough surfaces of the broken graphite fibers are clearly visible here. Compare these rough surfaces with the smooth cleavage facets on the broken boron fibers shown in fractograph 4115 (opposite page).

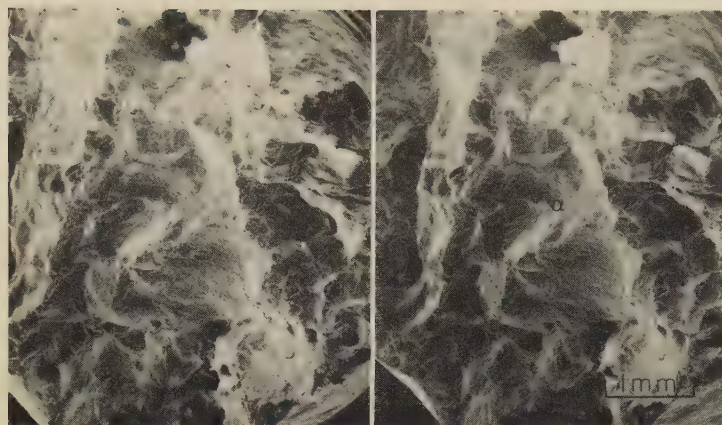
4121 Fracture at 425 C (797 F), 20 MPa (3 ksi) 11½×

The stereo pairs of SEM fractographs on these facing pages are of fracture surfaces produced in specimens of high-purity copper (99.999% Cu) by creep testing to rupture at temperatures ranging from 425 to 642 C (797 to 1188 F) and at tensile stresses ranging from 7 to 20 MPa (1 to 3 ksi). The material was continuously cast into ¾-in.-diam rod, swaged down to 0.55-in. diam, then machined into buttonhead specimens with gage sections 1½ in. long and ¼ in. in diameter. Before being tested, each specimen was heat treated in the creep-test furnace, first for 1 hr at 400 C (752 F) in hydrogen and then for 16 hr at 800 C (1472 F) in purified helium. The testing also was done in purified helium.

At low temperature or low stress, or both, the main mechanism of fracture was intergranular separation with accompanying microvoid coalescence, and the separated-grain facets were oriented at high angles relative to the tensile axis. At high temperature or high stress, or both, the fracturing was transgranular and highly plastic. At intermediate combinations of test temperature and stress, the main mechanism of fracture was the same as at low temperature or low stress

The specimen in fractographs 4121, 4122 and 4123 was tested at 425 C (797 F) and 20 MPa (3 ksi) and attained a steady-state strain rate of 2.0×10^{-6} per minute, fracturing in 76 hr, 54 min. These views show a fine texture of dimples, which resulted from microvoid coalescence, on fairly smooth separated-grain facets. The area at α in the center of the dimples is shown at higher magnification in 4122; note the uniform size of the dimples. Fractograph 4123, which is of an area of the fracture different from that in 4121, shows dimples with shapes that vary depending on orientation of the grain facets relative to the tensile axis.

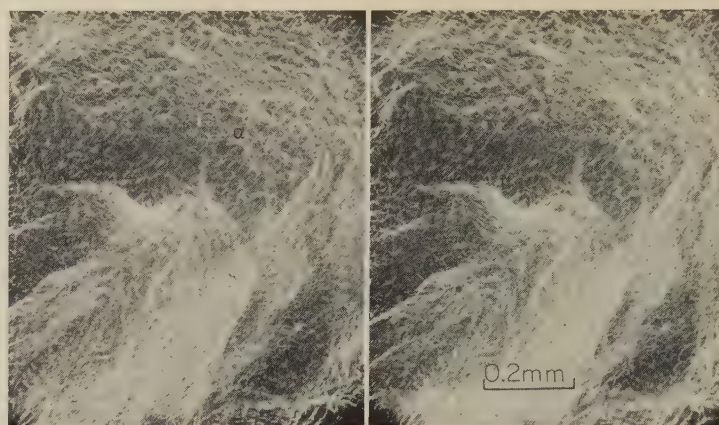
4122 Area at α in 4121, at higher magnification 60×

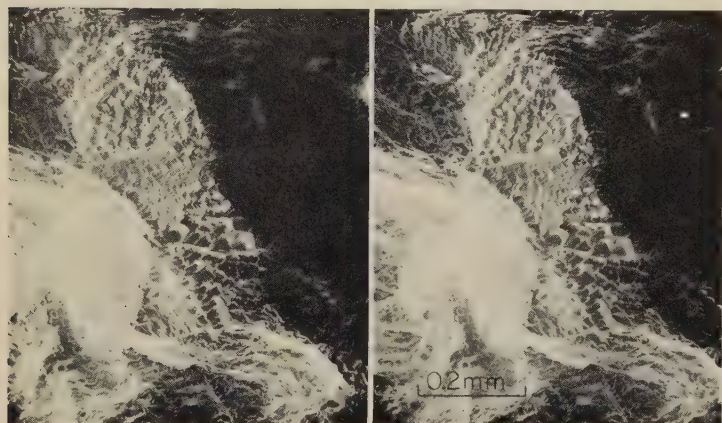
4123 A different area of the fracture in 4121 70×

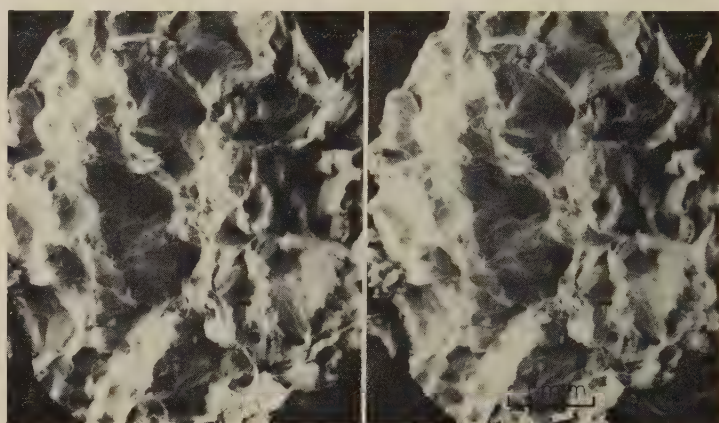
4124 Fracture at 440 C (824 F), 15.5 MPa (2.25 ksi) 11×

The specimen shown in fractographs 4124 and 4125 was tested at 440 C (824 F) and 15.5 MPa (2.25 ksi) and attained a steady-state strain rate of 7.0×10^{-7} per minute, fracturing in 308 hr, 30 min. These fractographs show two different areas of the fracture surface. The area shown in 4124 displays separated-grain facets oriented at high angles relative to the tensile axis; the area shown in 4125 (at higher magnification) clearly shows the small dimples on the grain facets.

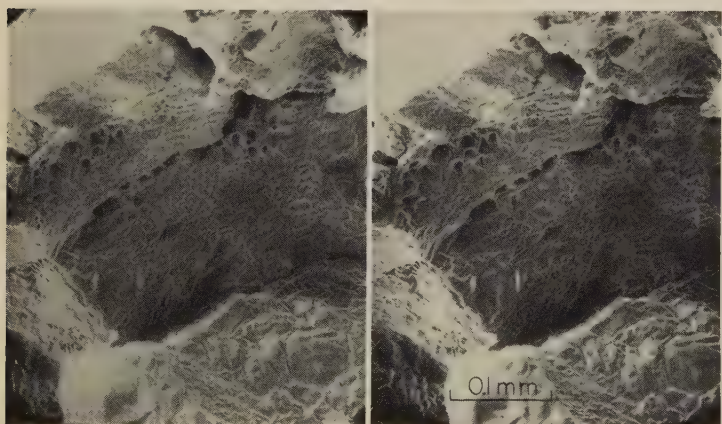
4125 A different area of the fracture in 4124 135×

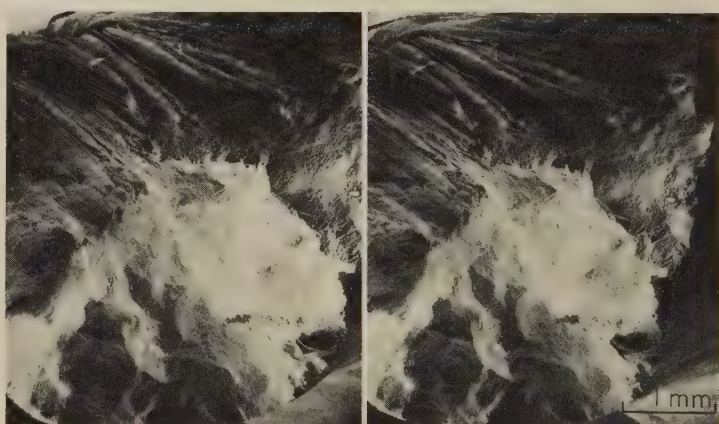
4126 Fracture at 525 C (977 F), 10.3 MPa (1.5 ksi) 12½×

The specimen in fractograph 4126 was tested at 525 C (977 F) and 10.3 MPa (1.5 ksi) and attained a steady-state strain rate of 5.0×10^{-7} per minute, fracturing in 300 hr, 6 min; its fracture surface has larger and smoother facets than those in 4124 and 4125. At top in this view is a region that fractured by transgranular rupture accompanied by plastic flow.

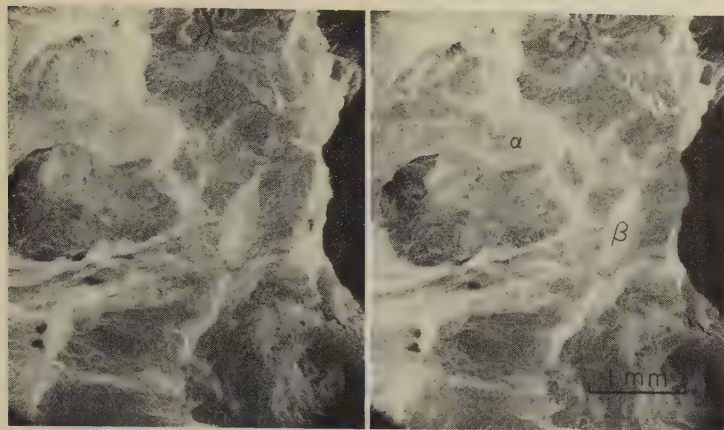
4127 Fracture at 540 C (1004 F), 10.3 MPa (1.5 ksi) 11½×

The specimen in fractographs 4127, 4128 and 4129 was tested at 540 C (1004 F) and 10.3 MPa (1.5 ksi) and attained a steady-state strain rate of 1.65×10^{-6} per minute, fracturing in 67 hr, 50 min. The fracture surface in 4127 exhibits regions with a fine texture of dimples (such as at α and β), separated-grain facets (at top right) somewhat like those in 4124, and highly plastically deformed features near the bottom edge of the large cavity at left center. Fractograph 4128, from near the cavity in 4127, shows different patterns of small dimples (at α and β) resulting from microvoid coalescence, and a region of extensive plastic flow (at bottom, adjacent to the large dimple). The dimples indicated by the arrow marked α are shown at still higher magnification in 4129. The small arrows in 4129 point to thermally etched

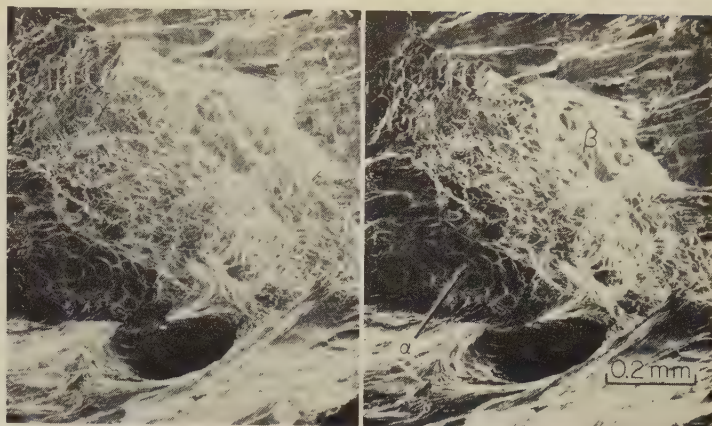
4128 Area at bottom of cavity at left center in 4127 60×

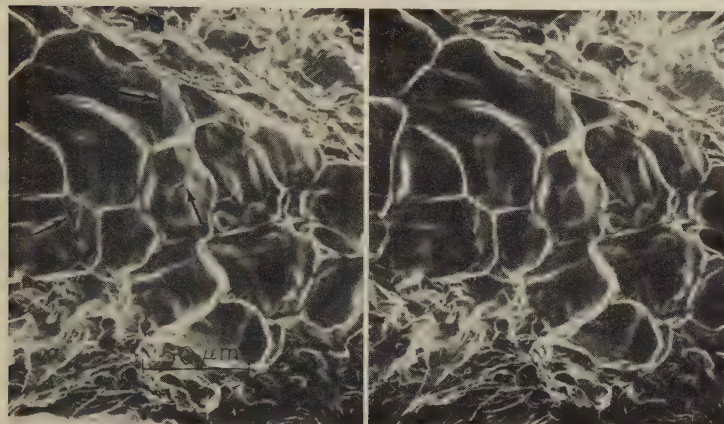
4129 Dimples indicated by arrow marked α in 4128 280×

networks of microstructural boundaries, which intersect the dimple boundaries and indicate that there is no relationship here of the dimple surfaces to crystallographic planes.

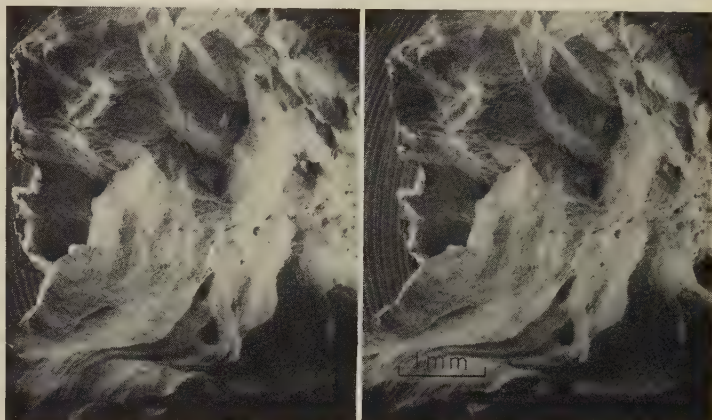
4130 Fracture at 602 C (1116 F), 10.3 MPa (1.5 ksi) 11½×

The specimen in fractograph 4130 was tested at 602 C (1116 F) and 10.3 MPa (1.5 ksi) and attained a steady-state strain rate of 4.8×10^{-6} per minute, fracturing in 40 hr, 54 min; its fracture surface shows a region of intergranular fracture (above the center) similar to that in fractograph 4124. Like the region at top in fractograph 4126, the region in the lower half of 4130 fractured by transgranular rupture accompanied by plastic flow.

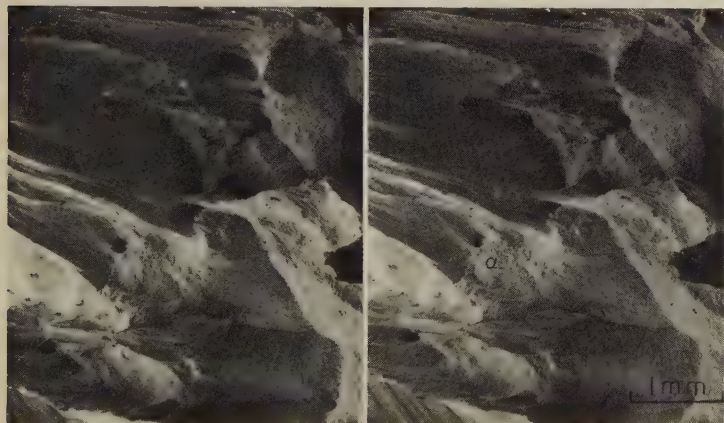
4131 Fracture at 642 C (1188 F), 7 MPa (1 ksi) 12×

The fracture surface of the specimen in fractograph 4131, which was tested at 642 C (1188 F) and 7 MPa (1 ksi), attaining a steady-state strain rate of 2.0×10^{-6} per minute and fracturing in 129 hr, 24 min, displays one region with a fine texture of dimples (at α). Extreme plastic flow, particularly at the grain just to the right of center, is seen in stereo to project out like a knife edge. Fractograph 4132 is a view at higher magnification of the region at α in fractograph 4131, showing patterns of dimples of various sizes.

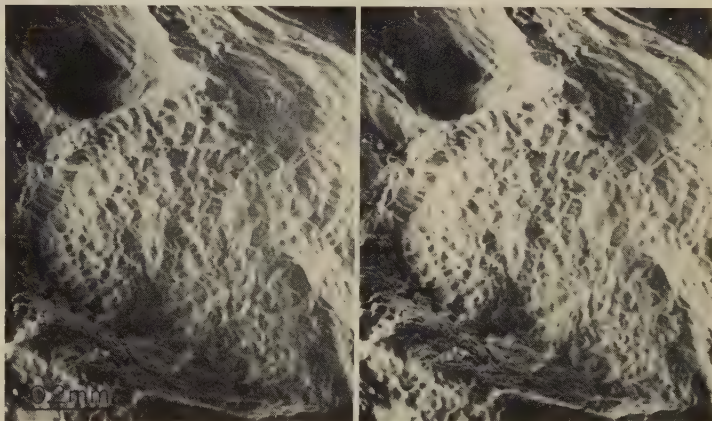
4132 Region at α in 4131, at higher magnification 60×

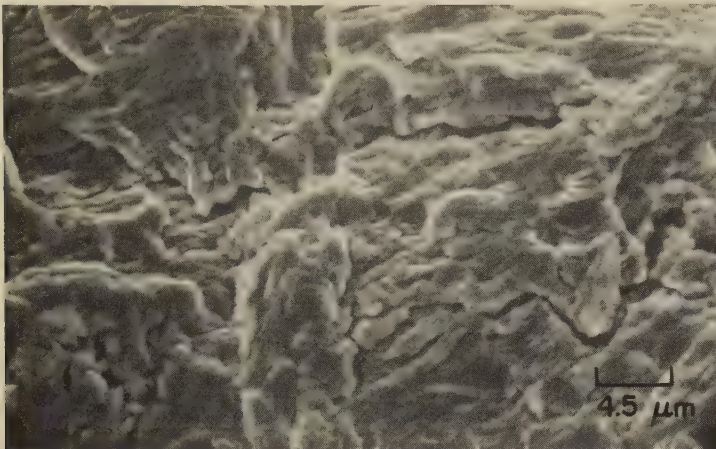
2200×

4133 Surface of a fatigue-test fracture in a notched specimen of oxygen-free, high-conductivity (OFHC) copper that had undergone a 67% reduction in cross-sectional area by cold work before being tested in dry air. The region shown here is 3 mm from the notch, where slow crack growth caused irregular striations to form. Note the numerous secondary cracks. See also 4134 to 4137.

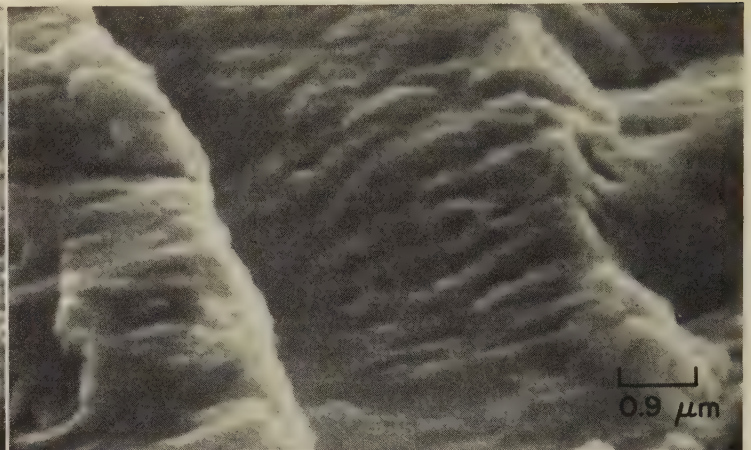
11,000×

4134 Another region of the surface of the fatigue-test fracture in OFHC copper shown in fractograph 4133 (left), also 3 mm from the notch. At this higher magnification, the irregularity of the fatigue striations is clearly visible. There are no intergranular secondary cracks in this region, and there are no fissures between the fatigue striations.

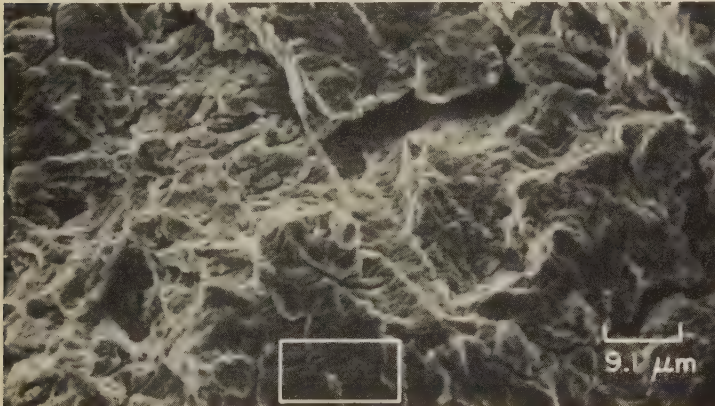
1100×

4135 A region of the surface of the fatigue-test fracture in OFHC copper shown in 4133, 5 mm from the notch, where the rate of crack growth was greater than in the region in 4133. Intergranular secondary cracks are clearly evident. Fatigue striations are not well resolved at this magnification. See 4136 (right) for a higher-magnification view of the outlined area.

4136 Higher-magnification view of the outlined area at the bottom of fractograph 4135 (left). Here, many of the fatigue striations have resulted in small fissures but show the same irregularity displayed in fractograph 4134 (above); however, the steps visible here (at center and near right edge) appear to be much smaller than the one in 4134.

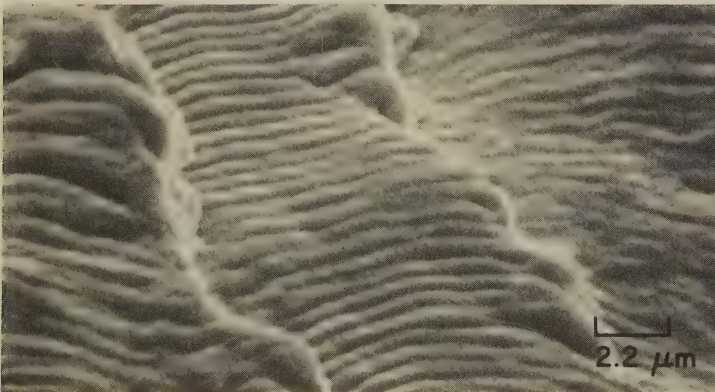
4137 Region of the fatigue-fracture surface in 4133 to 4136, 20 mm from the notch, where the rate of crack growth had increased considerably. The result of this high rate of crack growth is the array of very regular fatigue striations visible here, which are more typical of aluminum than of copper.

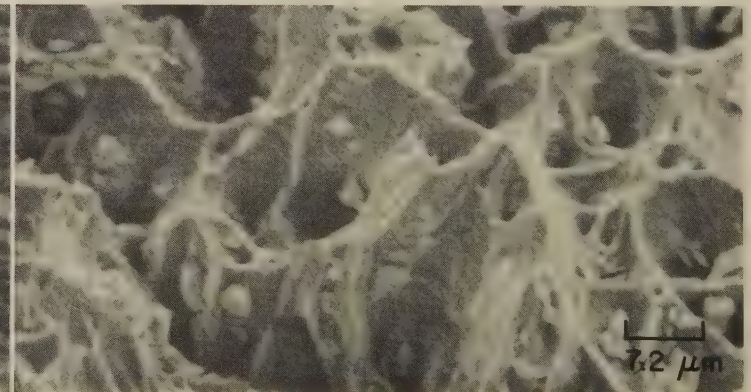
4138 Surface of a tensile-overload fracture in a specimen of free-machining copper, showing large dimples. Scattered throughout the structure are particles of Cu_2Te . The tellurium was added to the alloy to improve machinability (the particles of telluride act as chip breakers).

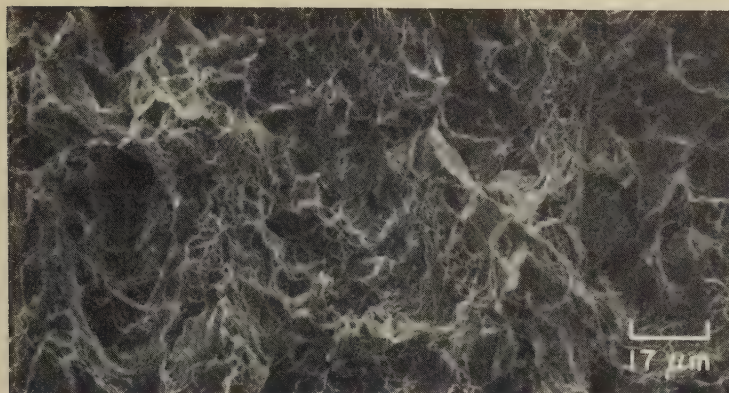
4139 Fracture surface of an underaged fracture-toughness test specimen of Cu-2.5Be alloy that had been aged for 1½ hr at 260 C (500 F) prior to being tested in air. Tensile strength was 930 MPa (135 ksi). Fracture was transgranular and produced the wide variety of dimple sizes shown here. There are some large pores, but there is little evidence of secondary cracking. Compare with fractograph 4140 (at right).

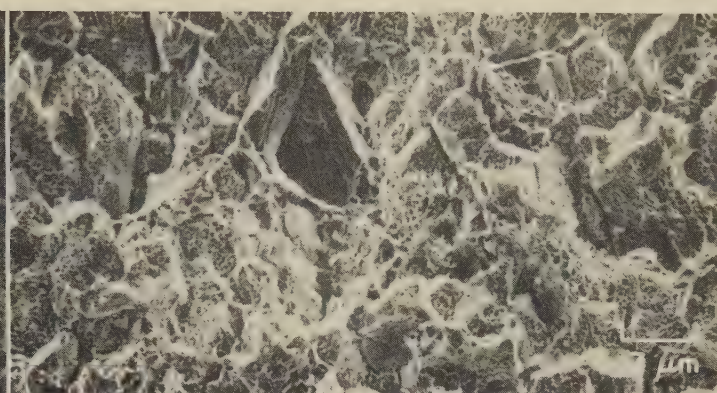
4140 Fracture surface of a fully aged fracture-toughness test specimen of Cu-2.5Be similar to that in 4139 (left) but aged 3 hr at 316 C (600 F) before being tested in air. Tensile strength was 1240 MPa (180 ksi). The dimples on the transgranular facets are much finer than in 4139, and there is a network of secondary cracks that appear to be intergranular. One facet (at top center) appears to have formed by quasicleavage.

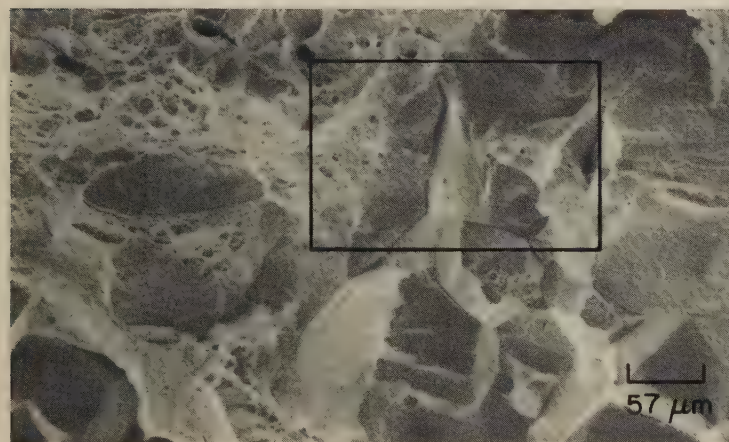
4141 Tensile-overload fracture in a fracture-toughness specimen of 64Cu-27Ni-9Fe alloy that underwent spinodal decomposition during heat treatment for 10 hr at 775 C (1427 F). The surface contains many intergranular facets with intervening regions of dimpled transgranular facets. See fractograph 4142 (right) for a higher-magnification view of the area in the rectangle.

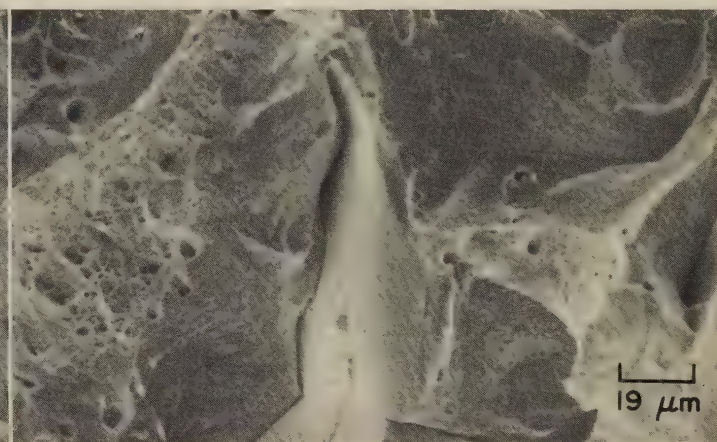
4142 A higher-magnification view of the area outlined by the rectangle in fractograph 4141 (left), revealing a fine structure of dimples, which resulted from microvoid coalescence, on the separated-grain facets. The regions of intergranular fracture here may have been caused by increased coarsening of the spinodal microstructure at the grain boundaries.

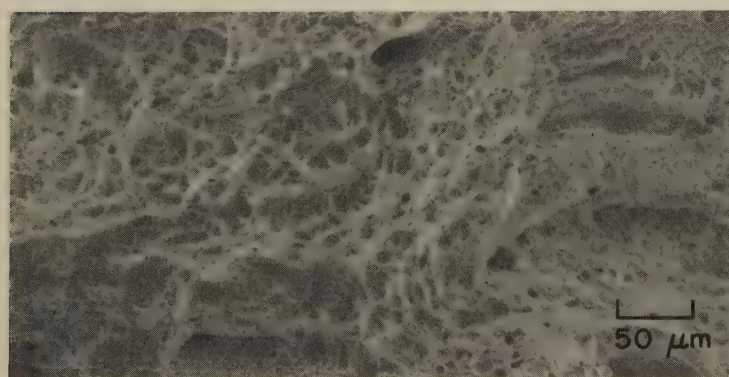
4143 Tensile-overload fracture in a fracture-toughness test specimen of the same 64Cu-27Ni-9Fe alloy as in 4141, but here spinodal decomposition occurred during heat treatment at 775 C (1427 F) for 100 hr. Only dimpled transgranular facets are visible (no intergranular facets); this may be due to a coarser spinodal structure resulting from the longer heat treatment.

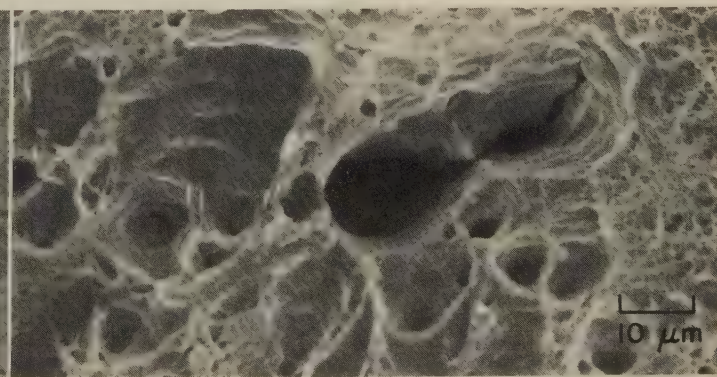
4144 Surface of the fracture in a fracture-toughness test specimen of the same 64Cu-27Ni-9Fe alloy as in fractographs 4141 to 4143, but which was heat treated at 775 C (1427 F) for 200 hr. Very fine dimples can be seen among the larger ones. The large cavity at the center of this view is believed to have resulted from a localized separation at a grain boundary.

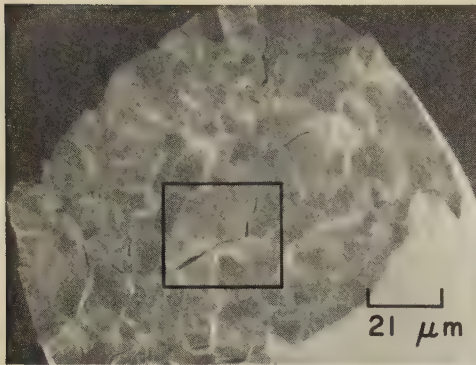
SEM fractograph 470×
4145 Surface of a brittle, intergranular fracture, produced by bending, in a polycrystalline iridium wire (0.127-mm diam) that had been annealed in vacuum for 2 hr at 1200 C (2192 F). See 4146, an enlarged view of the area in the rectangle.

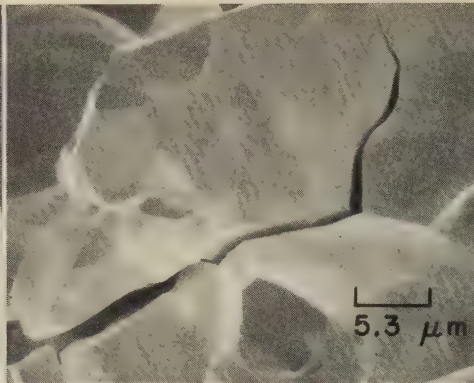
SEM fractograph 1900×
4146 Higher-magnification view of the area within the rectangle in fractograph 4145 (left). This entire area exhibits separated-grain facets and shows no evidence of plastic flow.

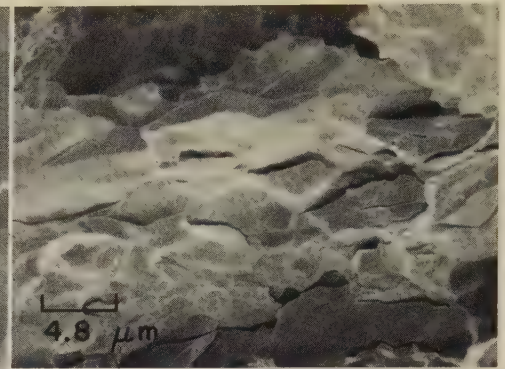
SEM fractograph 2100×
4147 Surface of a brittle, intergranular fracture, produced by bending, in an iridium sheet (rolled to 0.076 mm thick) that had been annealed for 2 hr at 1200 C (2192 F) in vacuum. Note the deep secondary cracks between the elongated grains.

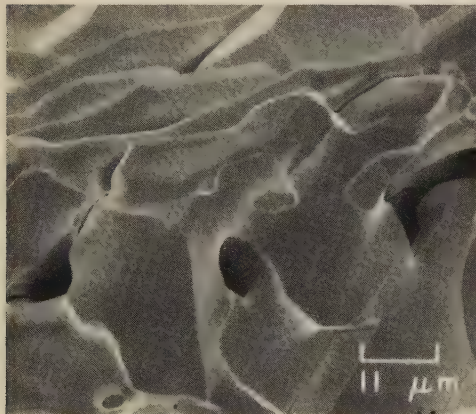
SEM micrograph 875×
4148 Surface of iridium sheet that had been annealed for 50 hr in helium at 1715 C (3119 F) to equilibrate a large grain size, then thermally faceted to permit study of possible impurity segregation.

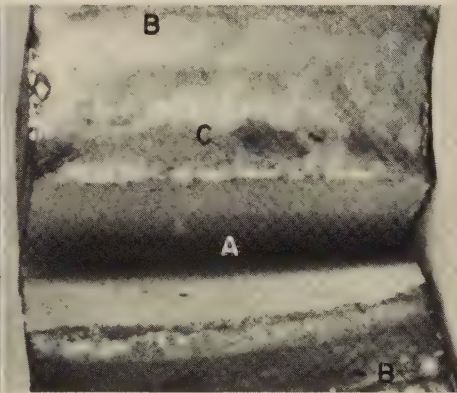
Light fractograph 6×
4149 View of a fracture (A) at the joint between a copper alloy CDA No. 260 (cartridge brass, 70%) strip (B) and a block of solder (C), opened by a tensile peel test*. Strip-to-solder interface between B and C at top did not open.

*In tensile peel tests of soldered joints, a strip of copper alloy 7/8 in. long by 3/8 in. wide by 0.005 in. thick is bent to a U shape with a 1/8-in. space between the sides of the U. The bend is dipped for 5 sec in freshly melted solder under a flux and then is removed to allow solidification of the small block of solder retained in the U. The free ends of the copper strip (legs of the U) are then pulled apart in a tensile-test machine to peel the strip from one side of the block of solder.

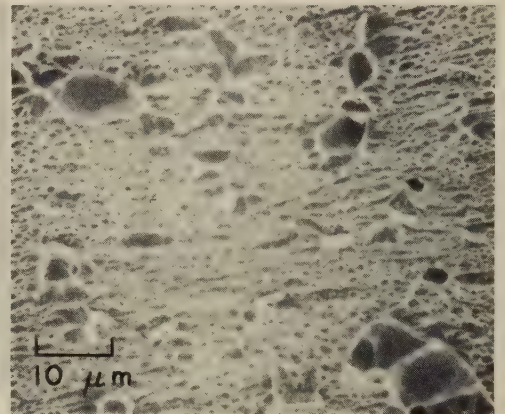
SEM fractograph 1000×
4150 Surface of a tensile peel-test* fracture in a solder joint with good strength and ductility that was made using 97.5Pb-1Sn-1.5Ag. The solder shows a fine continuous structure of dimples.

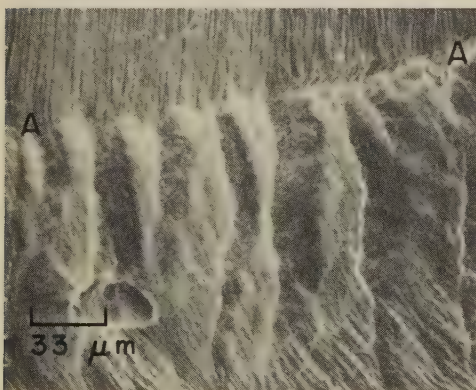
SEM micrograph 300×
4151 Free bulk-solder surface (perpendicular to fracture surface) of a tensile peel-test* specimen (after testing) prepared using 96.2Pb-3.8Sn-0.03Te alloy. Note flow below the grain boundary A-A.

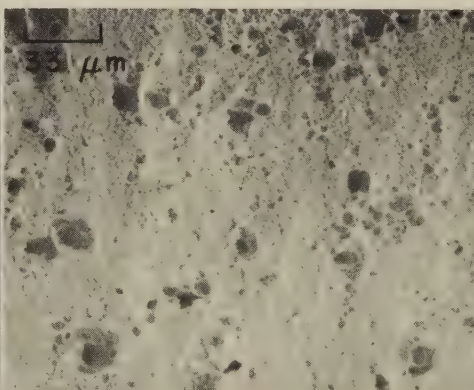
SEM fractograph 300×
4152 Surface of a tensile peel-test* fracture in the same solder alloy as in 4151. The soldered joint was strong and ductile, and the solder has a fine dimpled structure that is mostly unresolved here.

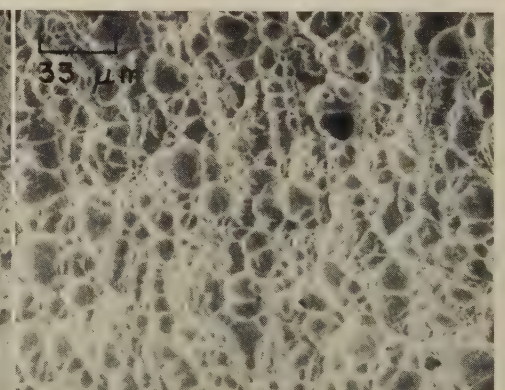
SEM fractograph 300×
4153 Surface of a tensile peel-test* fracture in a specimen prepared using 95.7Pb-3.8Sn-0.5Ag solder alloy. Structure of the solder is uniformly dimpled and is appreciably coarser than that in 4152.

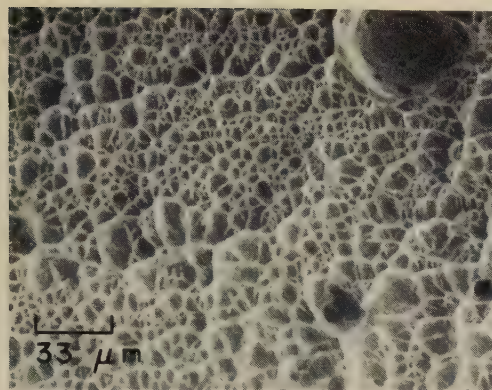
SEM fractograph 300×
4154 Surface of a tensile peel-test* fracture in 95Pb-3.8Sn-1.2Ag solder alloy. This solder is slightly different from that in 4153, but shows a similar array of dimples, most of which are of uniform size.

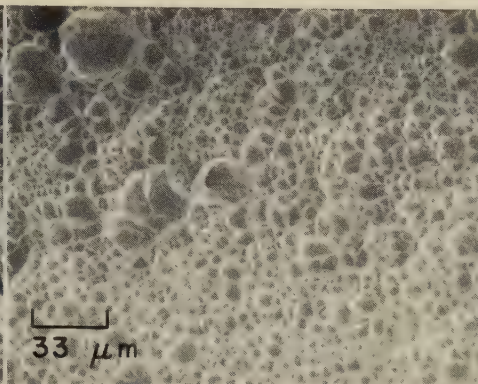
SEM fractograph 300×
4155 Surface of a tensile peel-test* fracture in 94Pb-4Sn-2Ag solder alloy, which contains slightly more silver and tin than the alloys in 4153 and 4154, showing somewhat smaller dimples. See also 4156.

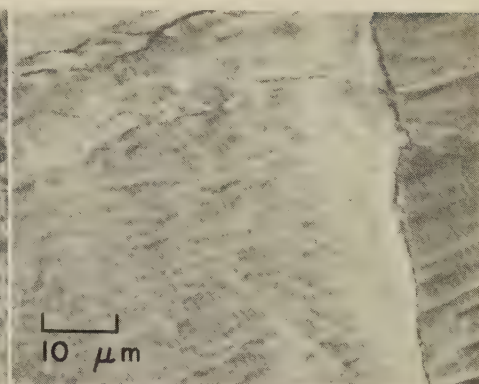
SEM micrograph 1000×
4156 SEM view of the free bulk-solder surface of the tensile peel-test* specimen in fractograph 4155, showing only slight surface slip but revealing both transgranular and intergranular cracks.

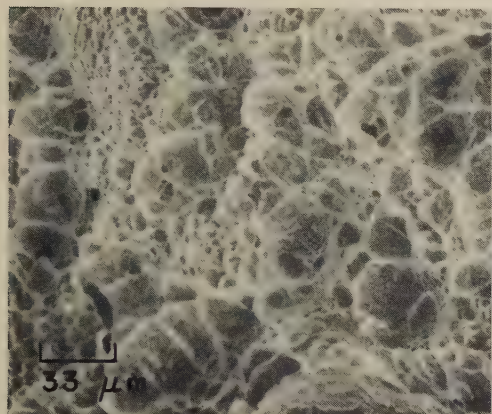
SEM fractograph 300×
4157 Surface of a tensile peel-test* fracture in 92.8Pb-6Sn-1.2Ag solder alloy. This alloy, which contains more tin than the alloy in 4154, shows a wide variation in dimple sizes.

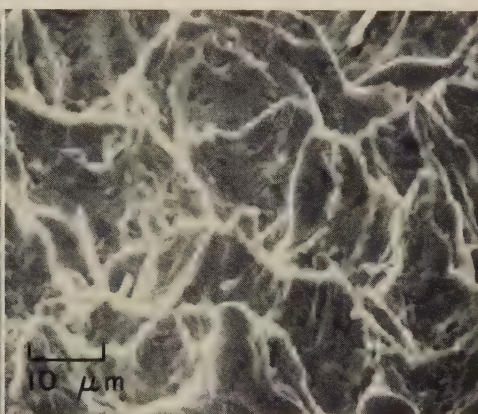
SEM fractograph 1000×
4158 Tensile peel-test* fracture surface of a joint with good strength and ductility, made with 85Pb-15Sn solder, showing a coarse-grained cellular structure. See also fractographs 4159 to 4162.

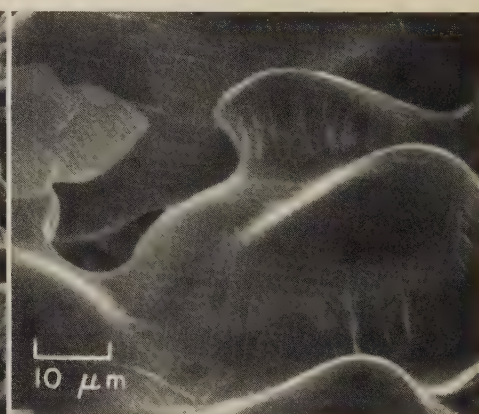
SEM fractograph 1000×
4159 Surface of a tensile peel-test* fracture in a low-strength, porous joint, made with the same solder as in 4158 (left), showing dendrite nodes apparently covered with a film, which has wrinkled.

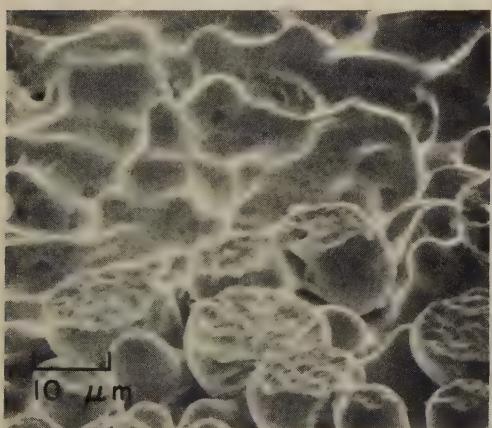
SEM fractograph 1000×
4160 Surface of a tensile peel-test* fracture in a low-strength, porous joint, made with the same solder as in 4158 and 4159. Note film-covered region (top) similar to 4159, and the cellular, ductile fracture surfaces of the dendrite arms (bottom).

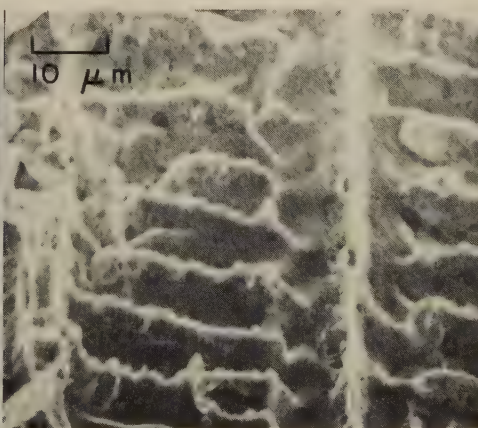
SEM fractograph 1000×
4161 Tensile peel-test* fracture surface of a joint with low strength due to hot tears (not shown) that formed during solidification, made with the same solder as in 4158 to 4160. Here, fracture is parallel to the direction of major dendrite growth.

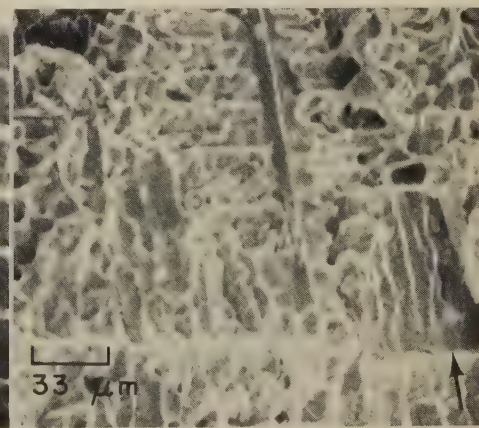
SEM fractograph 300×
4162 Surface of a tensile peel-test* fracture in another joint having low strength due to hot tears (as at arrow), made with the same solder as in 4158 to 4161 (85Pb-15Sn). Here, fracture has followed regions of interdendritic shrinkage. See 4163.

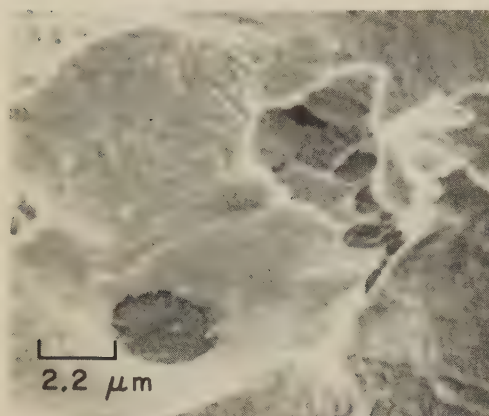
SEM fractograph 4500×
4163 Surface of a tensile peel-test* fracture in 85Pb-15Sn solder. Fracture in the ductile dimple at left began at the dark, round feature, where the bulk of the solder failed to cling to the initial layer.

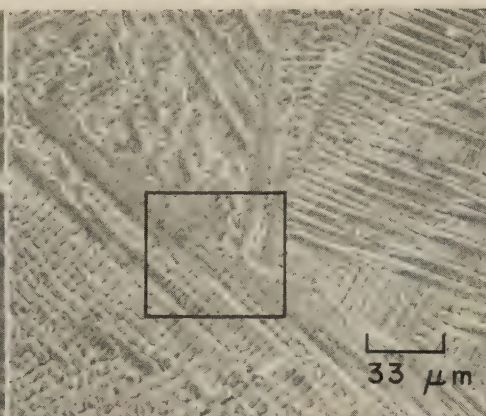
SEM micrograph 300×
4164 Free bulk-solder surface of a tensile peel-test* specimen soldered with 69.9Pb-29.6Sn-0.5Ag alloy. Note the complete lack of deformation. See 4165, an enlarged view of area in rectangle.

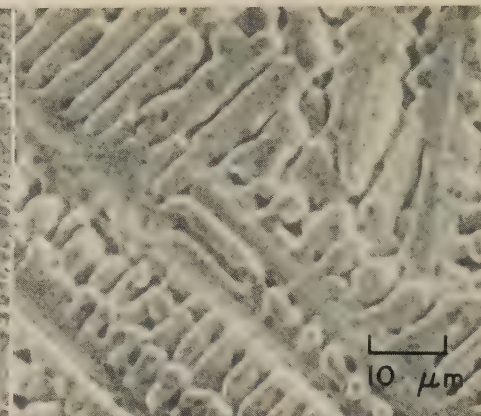
SEM micrograph 1000×
4165 Higher-magnification view of the area in the rectangle in micrograph 4164 (at left), showing more clearly the absence of surface deformation despite the plastic flow at the peeled joint.

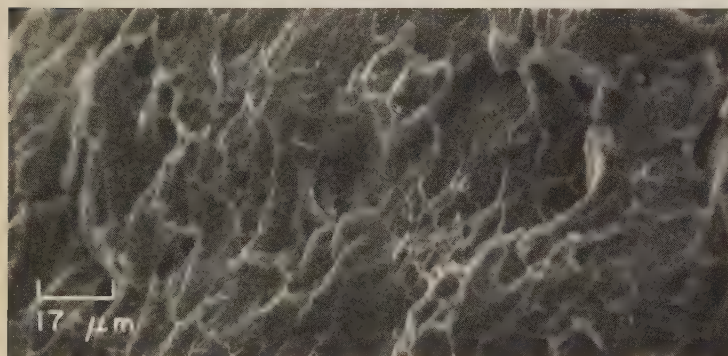
SEM fractograph 600×
4166 Surface of a tension-overload fracture in a specimen of magnesium alloy HM21A (97% Mg, 2% Th, 1% Mn) that broke during measurement of crack-growth rate in a fracture-toughness test. This ductile, dimpled surface is characteristic of magnesium alloys tested either in air or in a hydrogen atmosphere.

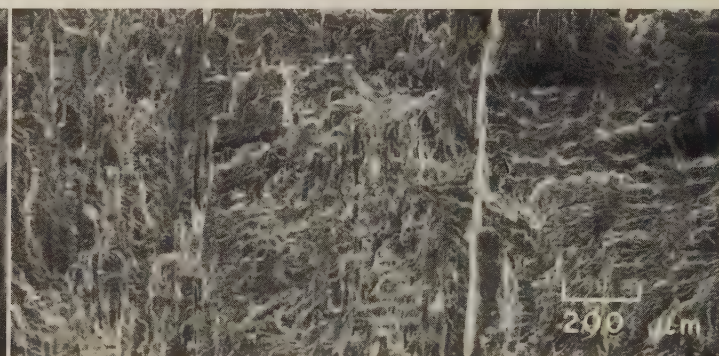
SEM fractograph 50×
4167 A low-magnification SEM view of the surface of a fracture produced in fracture-toughness testing of molybdenum alloy TZM (Mo-0.5% Ti-0.08% Zr) in air. The same type of brittle cleavage fracture shown here is obtained when this alloy is fracture-toughness tested in hydrogen. See also 4168.

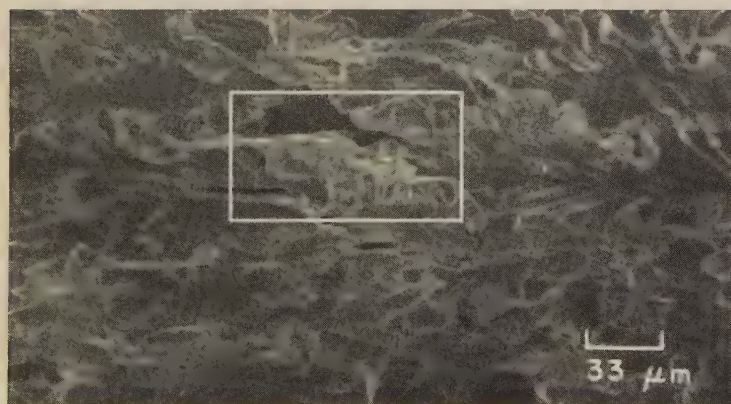
SEM fractograph 300×
4168 Same fracture surface as in 4167, shown at a higher magnification. Here the cleavage facets can be seen more distinctly, and there are no traces of dimples. There are several secondary cracks, which appear to be intergranular. See 4169 for a higher-magnification view of the area in the rectangle.

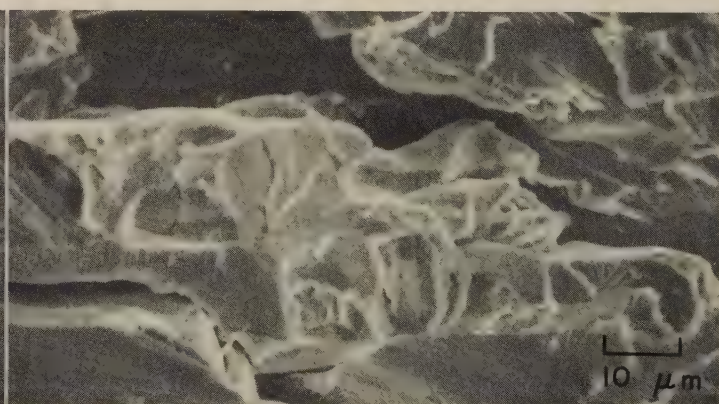
SEM fractograph 1000×
4169 A higher-magnification view of the area in the rectangle in fractograph 4168 (left). In this view, the cleavage steps on the facets are clearly visible. Except for the secondary cracks, this portion of the fracture surface appears to be composed entirely of transgranular facets.

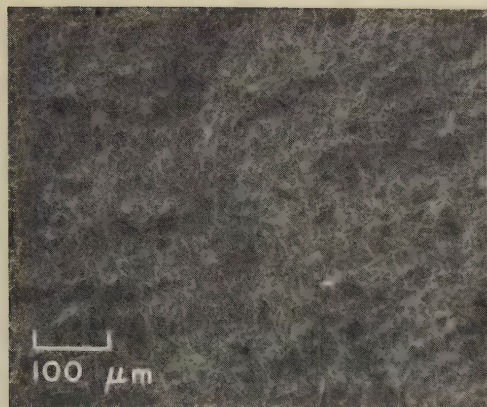
SEM fractograph 100×
4170 Fracture in a double-cantilever-beam, fracture-mechanics specimen of titanium alloy Ti-5Al-2.5Sn solution treated at 1066 C (1950 F), furnace cooled, and wedge-opening loaded in air at 24 C (75 F). See also fractograph 4171 (at right).

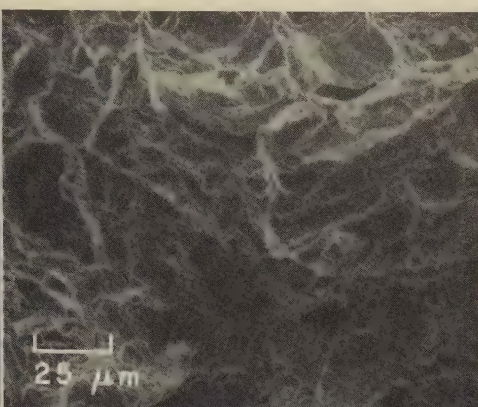
SEM fractograph 400×
4171 Higher-magnification view of the fracture surface shown in 4170. It is evident that this fracture is one of dimpled overload, with suggestions of ledges. See also fractograph 4172 (right).

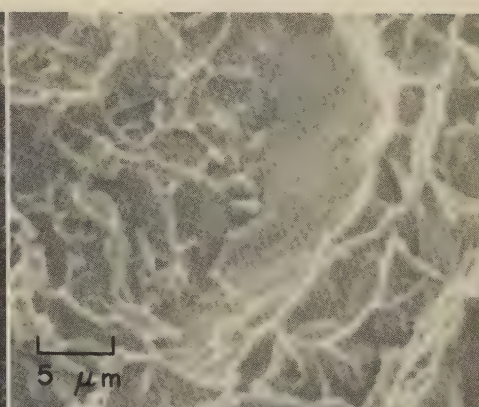
SEM fractograph 2000×
4172 A view at still higher magnification of the fracture surface shown in fractographs 4170 and 4171. Visible at center is a ledge, which has resulted from step-wise propagation of the crack.

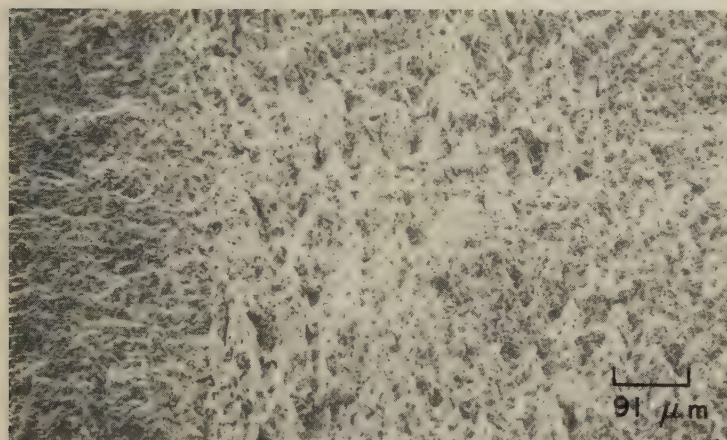
SEM fractograph 110×
4173 Fracture surface of a ductile fracture-toughness specimen of titanium alloy Ti-6Al-4V that was solution treated for 40 min at 829 C (1525 F), water quenched, aged at 510 C (950 F), then loaded in three-point bending (in air). See also 4174 to 4177.

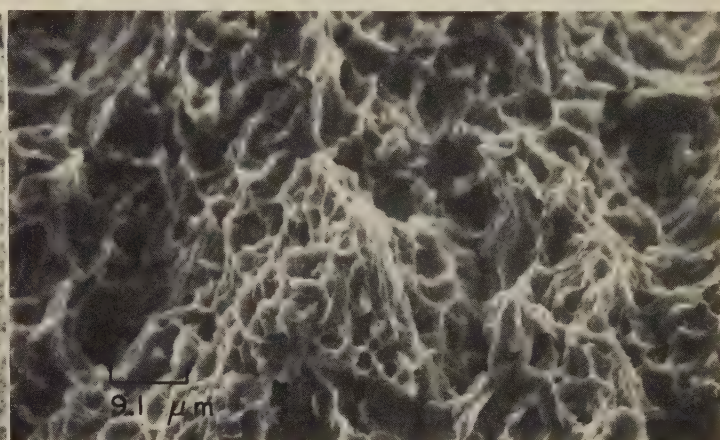
SEM fractograph 1100×
4174 Higher-magnification view of the fracture surface in 4173, typical of fractures produced in this alloy in air after various solution treatments. Entire surface shows dimpled fracture of fine, equiaxed alpha phase that ruptured in ductile shear.

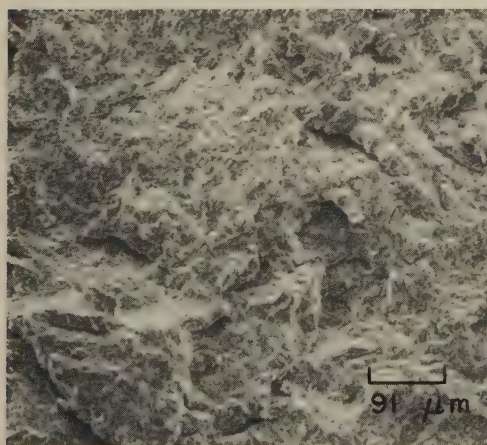
SEM fractograph 110×
4175 Fracture surface of a specimen of Ti-6Al-4V alloy similar to the specimen shown in 4173 and having the same history, but tested in a hydrogen atmosphere. The principal features here are numerous secondary cracks. See also 4176 (right).

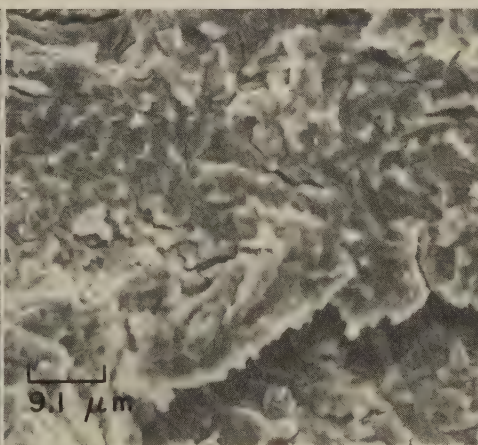
SEM fractograph 1100×
4176 Higher-magnification view of the fracture surface shown in 4175 (at left). The embrittlement of this specimen by hydrogen was slight (about 12%). Fracture was by a mixture of shear rupture and transgranular cleavage. See also 4177.

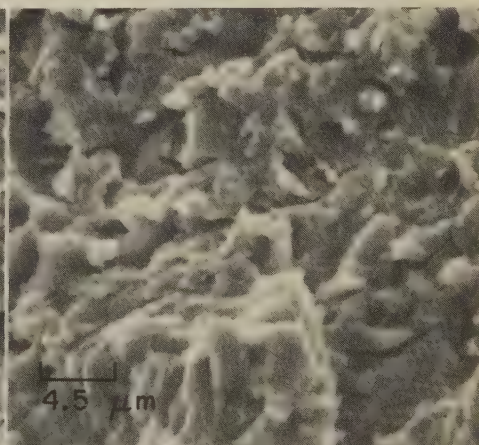
SEM fractograph 2200×
4177 Same fracture surface as in fractographs 4175 and 4176, but shown at even greater magnification. Many small secondary cracks are present among moderate-sized dimples.

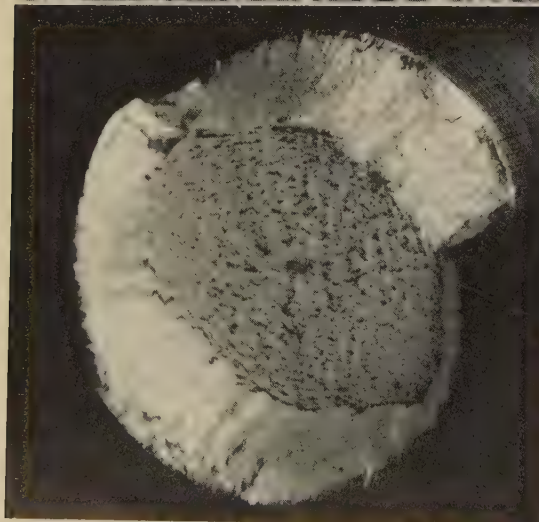
4178 Tensile-overload fracture surface of an unnotched specimen of titanium alloy Ti-6Al-4V heat treated to a tensile strength of 1158.8 MPa (168.5 ksi) and 47% reduction in area. A classic example of cup-and-cone fracture having a flat, fibrous central zone. See 4179.
